## 2. 측정위치도, 사진대지 및 분석결과

### (1) 측정지점

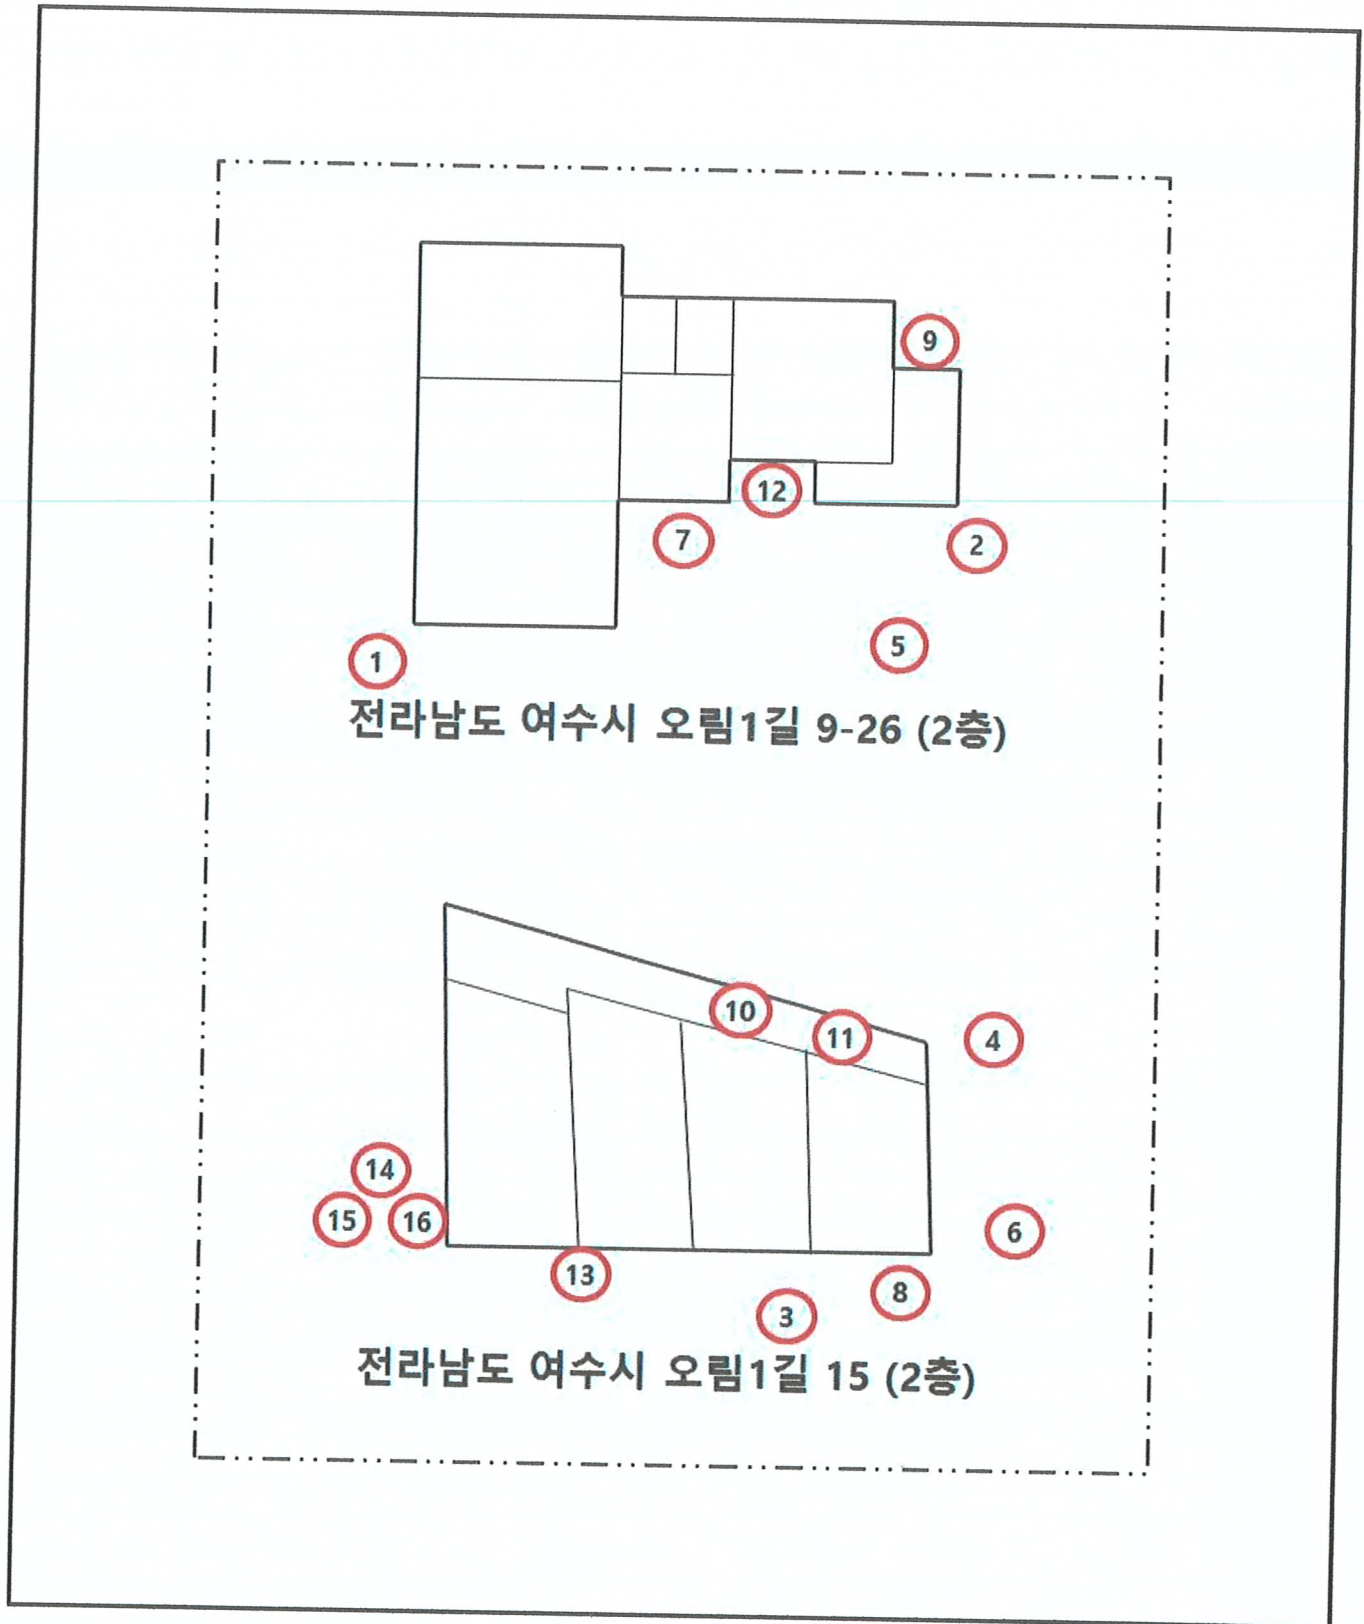
시료번호	측정지점	총 유량 (ℓ)	측정일시	측정결과 (f/cc)	초과여부 (검출한계:0.01/CC)
# 1	부지경계선①	2420	09:00~13:00	0.001	검출한계 미만
# 2	부지경계선②	2460		0.001	검출한계 미만
# 3	부지경계선③	2440		0.002	검출한계 미만
# 4	부지경계선④	2420		0.001	검출한계 미만
# 5	위생설비 입구①	412	09:00~09:40	0.003	검출한계 미만
# 6	위생설비 입구②	408	11:20~12:00	0.002	검출한계 미만
# 7	작업장 주변①	1240	09:00~11:00	0.002	검출한계 미만
# 8	작업장 주변②	1220	11:20~13:20	0.003	검출한계 미만
# 9	음압기 토출구①	420	10:00~10:40	0.003	검출한계 미만
# 10	음압기 토출구②	412	11:20~12:00	0.004	검출한계 미만

시료번호	측정지점	총 유량 (ℓ)	측정일시	측정결과 (f/cc)	초과여부 (검출한계:0.01/CC)
# 11	음압기 토출구③	416	13:00~13:40	0.003	검출한계 미만
# 12	폐기물 반출구①	408	10:00~10:40	0.004	검출한계 미만
# 13	폐기물 반출구②	412	13:00~13:40	0.003	검출한계 미만
# 14	폐기물 야적장①	404	11:00~11:40	0.003	검출한계 미만
# 15	폐기물 야적장②	412	13:00~13:40	0.004	검출한계 미만
# 16	폐기물 보관지점	420	14:00~14:40	0.001	검출한계 미만
